# DELAMINATING PAINT IN AN 18<sup>TH</sup> CENTURY CANVAS WALL PAINTING

A Case Study at the von Echstedt Manor

Degree project for Master of Science with a major in Conservation  
2021, 30 HEC  
Second Cycle  
[2021:26]

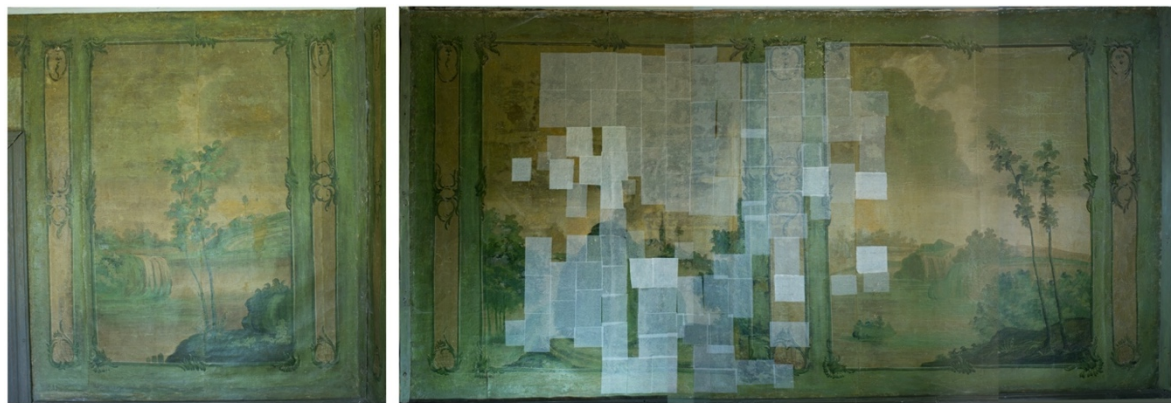
Figure 1. The wall paintings on the east and south wall in the Green Chamber at the von Echstedt Manor. Collage of photographs taken in September 2020.

The canvas wall paintings investigated in this study are situated on the east and south wall in the Green Chamber in the von Echstedt manor and measure 163x188 cm and 188x360 cm respectively. The paintings are depicting three different landscape sceneries separated and framed by painted fields with decorative rocaille ornaments (fig. 1, fig. 4). The artist is not known.

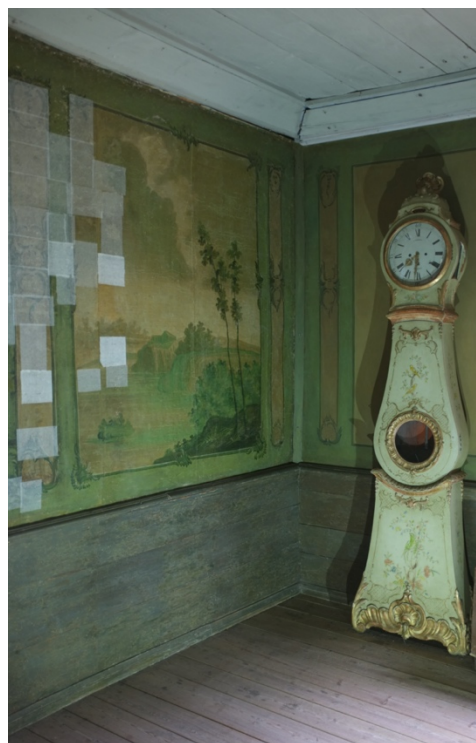
Figure 4. Detail of the wall painting on the south wall in the Green Chamber. Behind the clock is a replica painting from the 1950s.

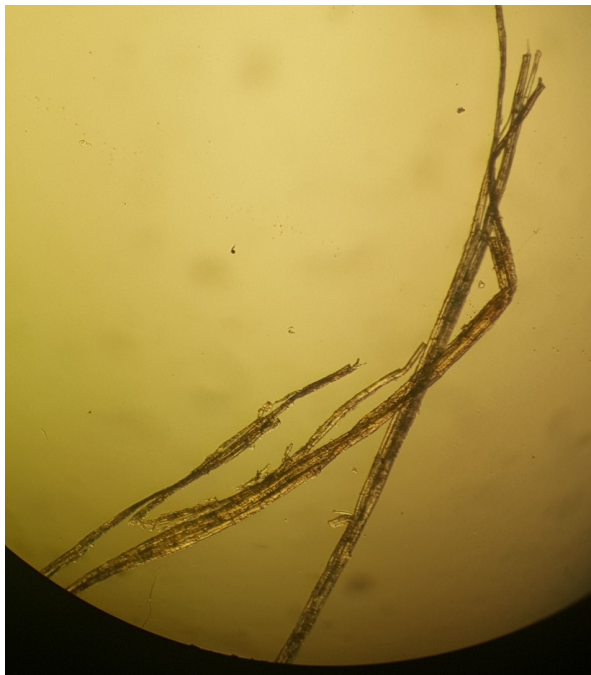
Figure 6. A canvas fiber under microscope with transmitted light. Nodes can be seen across the bundles of fibers. The fabric is identified as linen.

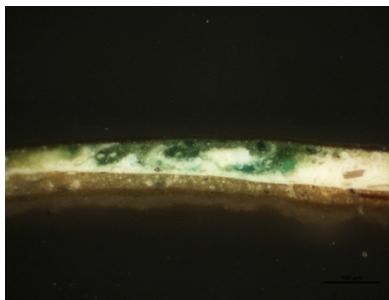
Figure 8. Cross section of sample 6. Dark green and white painted wet in wet on top of the brown imprimatura

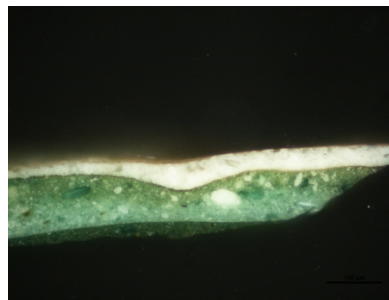
Figure 9. Cross section of sample 5. The white paint used for details is seen on top of two layers of green

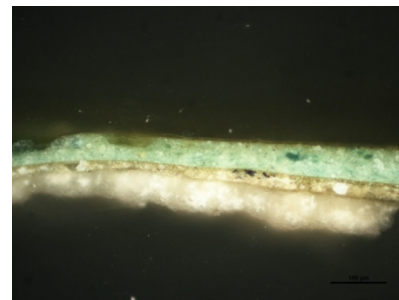
Figure 10. Cross section of sample 1. The ground layer, the imprimatura and a green paint is visible

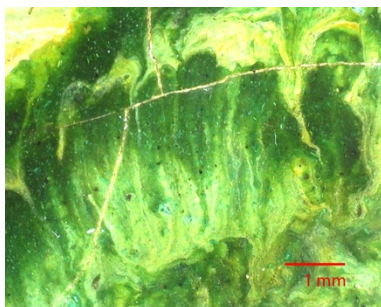
Figure 11. Micrograph of area 14. The marbled effect of wet in wet painting of dark and light green paint.

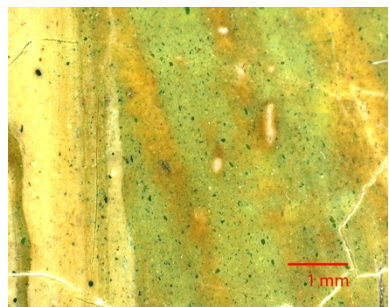
Figure 12. Micrograph of area 10. The brown imprimatura is visible between brushstrokes and large pigment particles are seen on the paint surface.

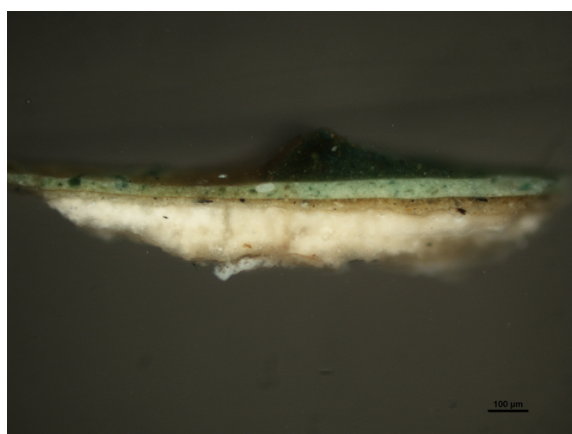
Figure 20. Cross section of sample 7 named 7.1. The ground, the imprimatura, a light green paint and the dark green paint can be seen in the cross section.

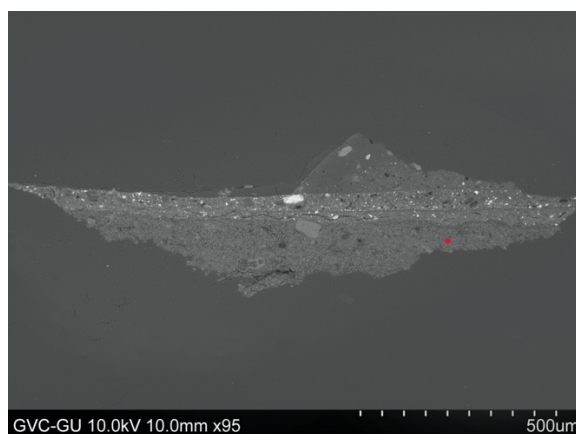
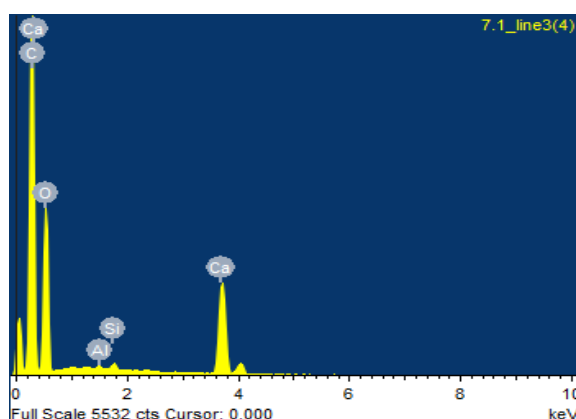
The ground layer, present in sample 7.1., is analysed with EDX in 34 different spots. The spots are distributed along three lines across the sample, and in one more area (appendix 4, p. 56). The prevailing elements detected in the ground layer are oxygen (O) and calcium (Ca), indicating that the main constituent is most probably chalk, calcium carbonate ( $\text{CaCO}_3$ ). FTIR analysis of a sample of the ground layer also shows the presence of calcium carbonate ( $\text{CaCO}_3$ ) with sharp peaks at wavenumbers 711, 870 and  $1794\text{ cm}^{-1}$  (Derrick, Stulik & Landry 1999, p. 117) (IRUG 2021, spectrum IMP00115). In most of the spots analysed, there are small amounts of silicon (Si), and in some spots also magnesium (Mg) and aluminium (Al), all of which can be attributed to common impurities of silt and clay found in natural chalk (Gettens, West Fitzhugh & Feller 1993, p. 203, p. 210). In the bright white material seen underneath the ground layer in figure 20, the elements listed above are present, as well as zinc (Zi) and titanium (Ti). Zinc oxide and titanium dioxide were not commercially available until 1842 and 1916 respectively, which is too recent for the pigments to be a part of the painting's original composition (Kühn 1986, p. 171) (Eastaugh 2008, p. 412, p. 370). The white material is most likely a fragment of the ground used for the adjacent 1950s retouch.

Figure 21. BSE- image of cross section 7.1. One of the spots analysed with SEM-EDS is marked with a red dot.

Figure 22. The elements detected with SEM-EDS in the spot marked with a red dot in figure 21 are typical for most spots analysed in the ground layer and indicate the pigment used is chalk ( $\text{CaCO}_3$ ).

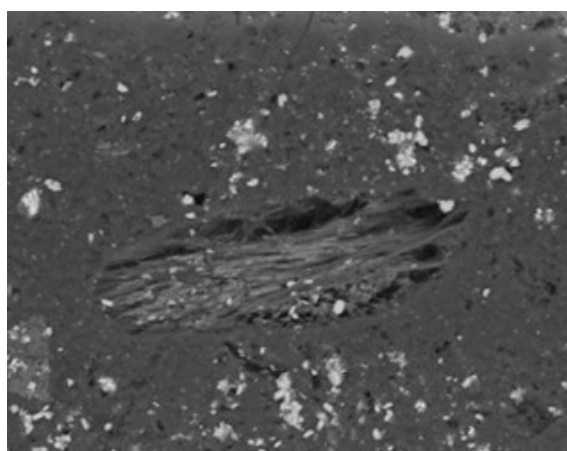
Figure 23. A green pigment particle in BSE-image of cross section 5.1. The fibrous structure is characteristic of malachite ( $\text{CuCO}_3 \cdot \text{Cu}(\text{OH})_2$ ).

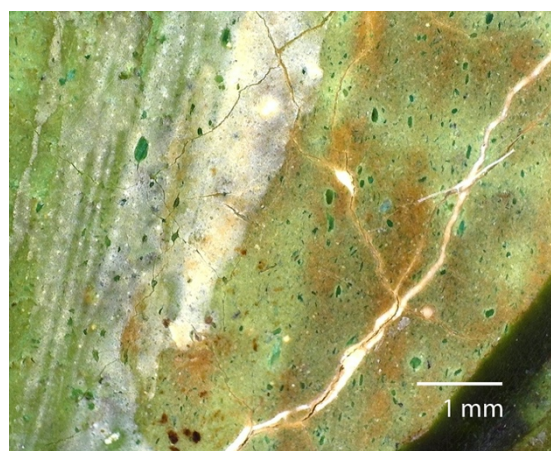
Figure 24. Micrograph of area 15. Pigment particles visible on the surface of the painting have the characteristic angular shape of malachite. Blue particles are visible as well.

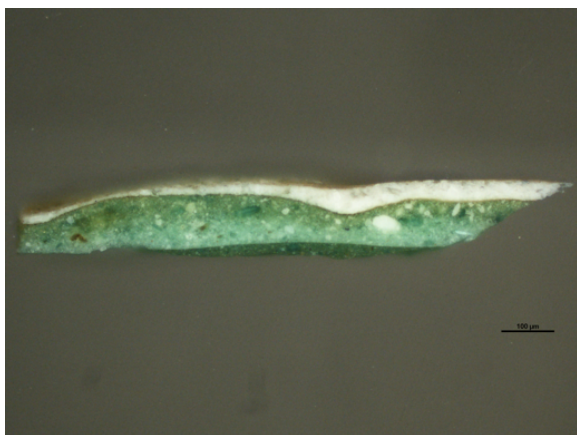
Figure 25. Cross section from sample 5 (5.1.). Two layers of green paint and the white paint used for details can be seen in the cross section.

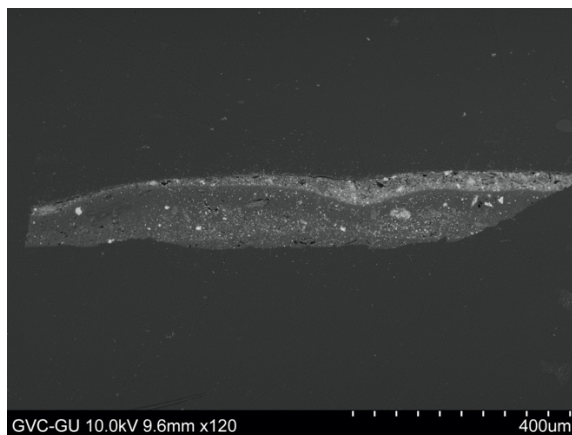
Figure 26. BSE image of cross section 5.1. Heavy elements like lead appear bright in the BSE-image.

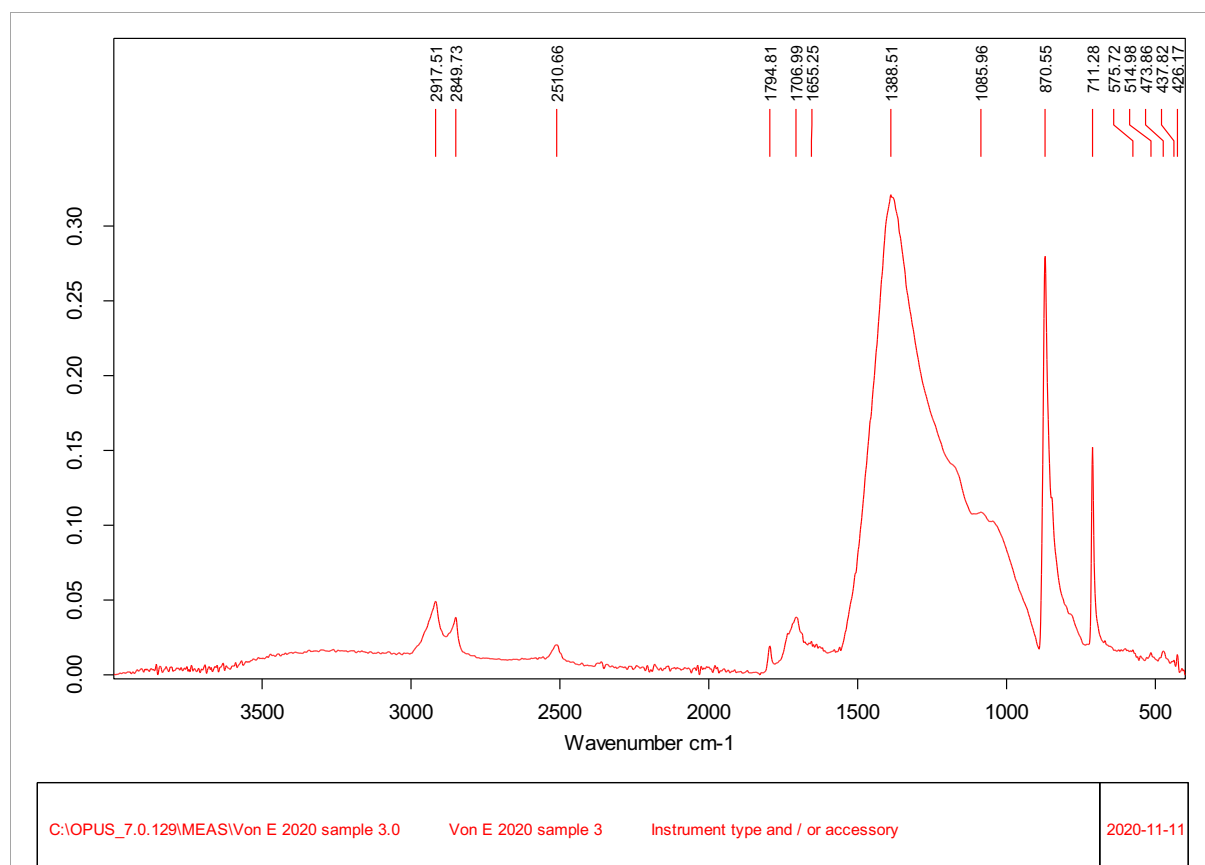
Figure 31. FTIR spectrum of sample 3, ground layer.

FTIR analysis of sample 3 from the ground layer indicates that both oil and protein are present in the sample. The amide groups in proteins absorb infrared radiation in the region  $1650\text{--}1450\text{ cm}^{-1}$ . In the spectrum acquired from the analysis of the ground layer there are peaks in this area, although not very sharp and distinct. There are also two sharp peaks significant for oil in the hydrocarbon stretching area at  $2917\text{ cm}^{-1}$  and  $2849\text{ cm}^{-1}$ . The third peak important for identifying oil can be seen in the acquired spectrum at around  $1740\text{ cm}^{-1}$ , but it is partly obscured by other peaks in the same region (Derrick, Stulik & Landry 1999, p. 103) (fig. 31). Since chalk is identified as the only pigment used in the ground layer, it is possible that the binding medium is proteinaceous, i.e., an animal glue. Chalk is usually not used alone as a pigment in oil paint, because its low refractive index makes it transparent when mixed with oil (Gettens, West Fitzhugh & Feller 1993, p. 206). The porous ground layer may have absorbed oil from the succeeding paint layer, which is the light brown imprimatura. In the cross sections, there is no distinct line between ground layer and the imprimatura, which also may indicate that oil is absorbed into the ground layer (fig. 20). One has to keep in mind that, because of the repeated consolidation with sturgeon glue, proteins could possibly be found anywhere in the paint layers. A fiber from the canvas support is analyzed with FTIR to detect traces of the sizing, another animal glue. The acquired spectrum shows protein peaks, but it is impossible to tell if these originate from an animal glue used for sizing, or from the sturgeon glue used for consolidation.

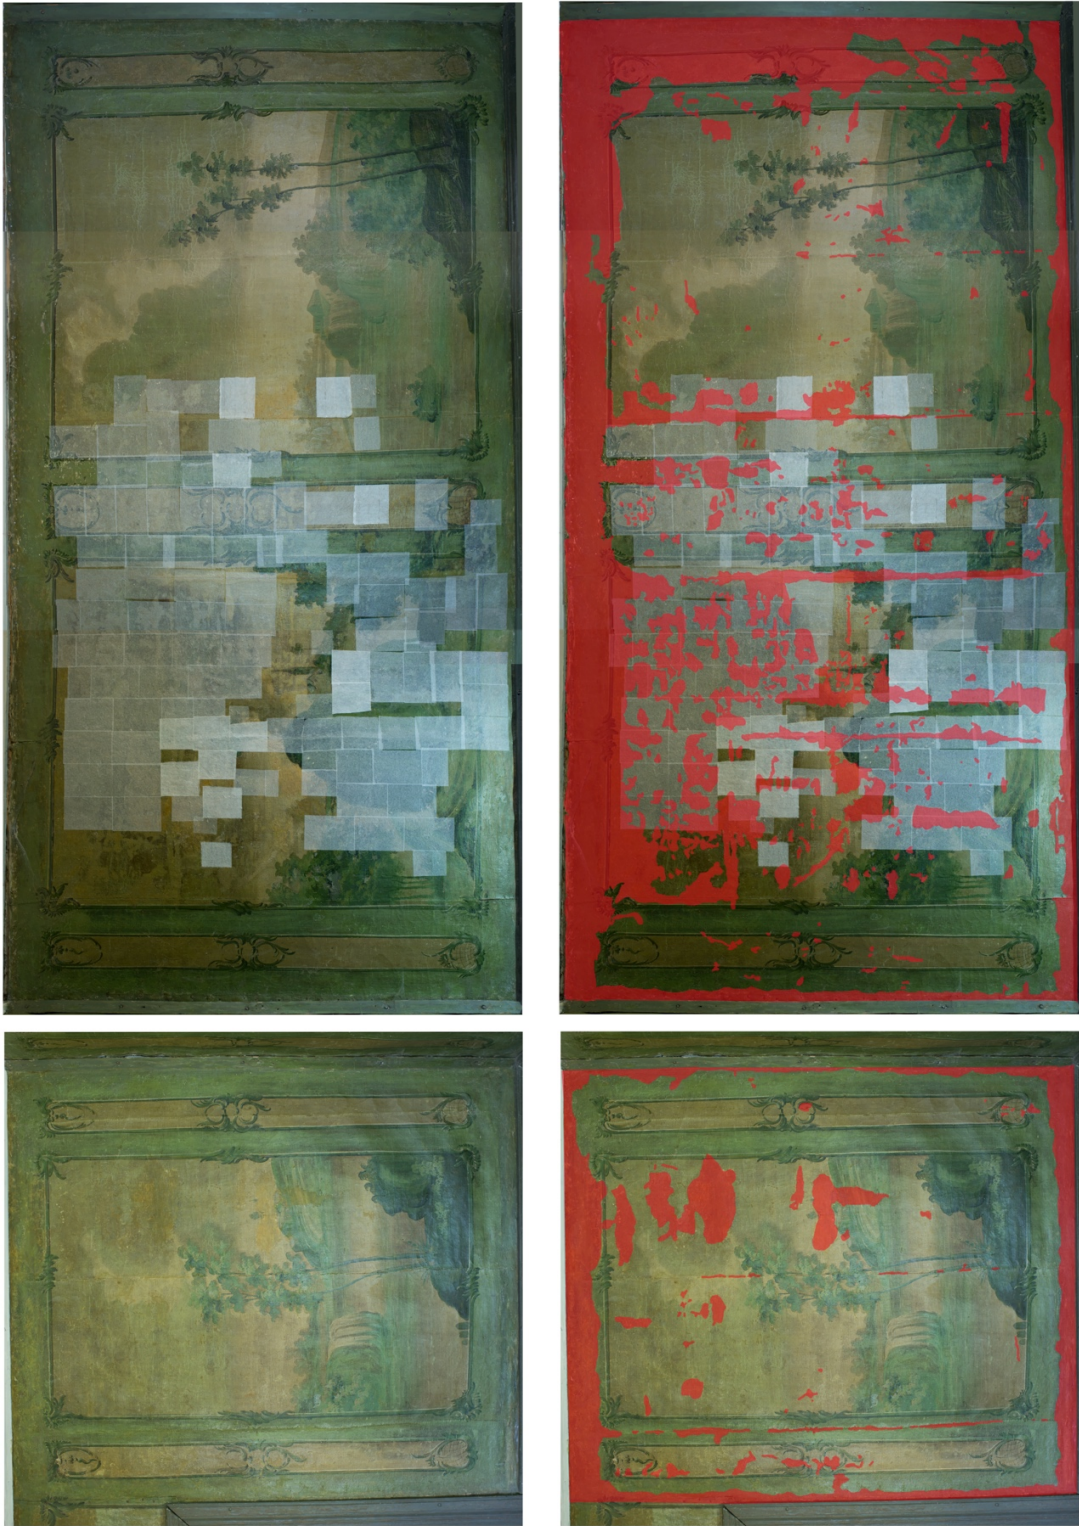
There are areas where both the original ground and paint are missing (appendix 2, p. 50). In the retouches in these areas the structure of the canvas is visible, indicating that the retouch is painted on bare canvas or on a very thin ground layer. These retouches correlate with the losses seen in the pre-restoration photograph from 1955, and it is concluded that the retouches originate from the 1955 restoration (fig. 5, p. 20). There are also later retouches visible on top of some of the 1950s retouches. These retouches appear dark in UV-light and are most likely the watercolor retouches mentioned in the conservation report from 1992 (fig. 17). The 1950s retouches seem to be varnished with the same varnish as the rest of the paintings. The reconstructed paintings on the west wall also seem to have the same varnish. Nor the retouches or the reconstructed wall paintings show signs of cracking or delamination.

Figure 36 above. Overview collage of photographs of the wall paintings. Figure 37 below. Same collage as above with 1950s retouches mapped in red.

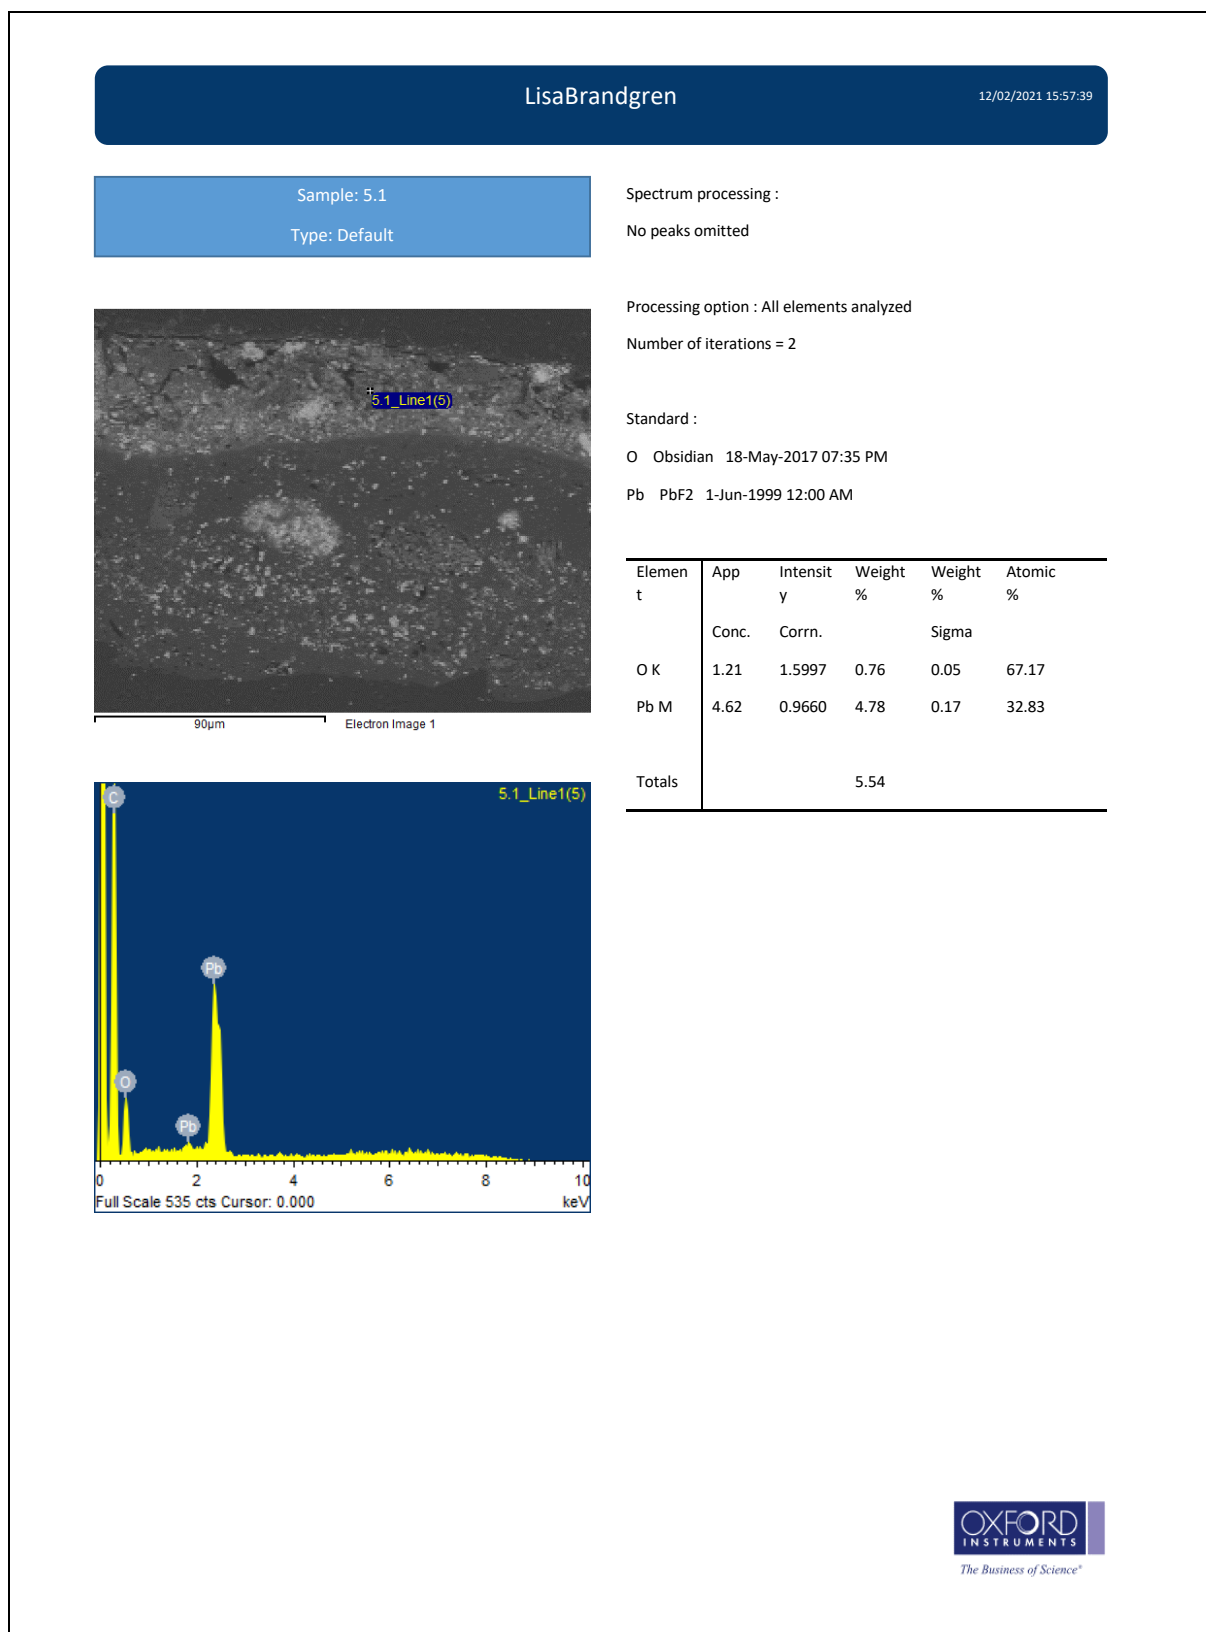
Table 9. SEM-EDS analysis of possible lead soap aggregate in cross section 5.1. (sample 5).

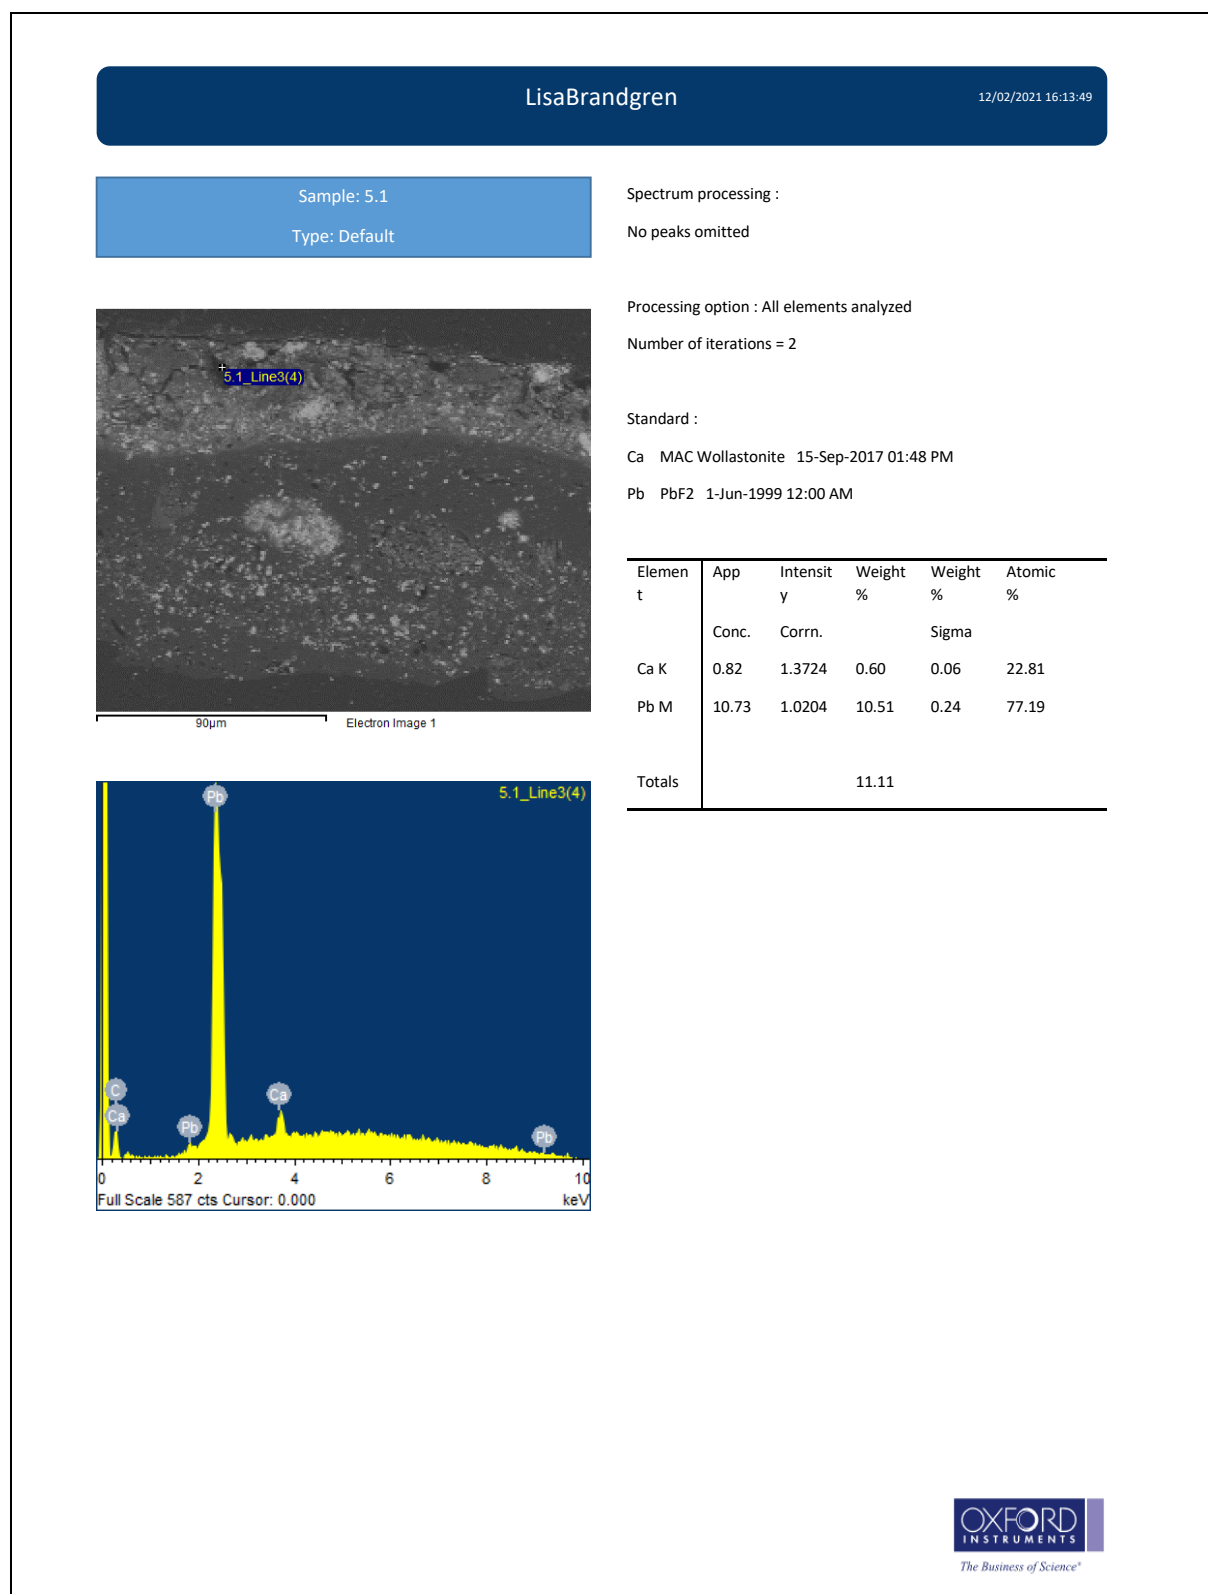
Table 10. SEM-EDS analysis of possible lead soap aggregate in cross section 5.1. (sample 5).
